**PRELIMINARY ACOUSTIC TESTS IN THE NEW HEADQUARTERS, WALES
(BAYNTON HOUSE, CARDIFF)**

Technological Report No. B-089/5
UDC 534.861.1 1966/49

D.K. Jones, B.Sc., A.Inst.P., A.M.I.E.R.E., Grad.I.E.E.

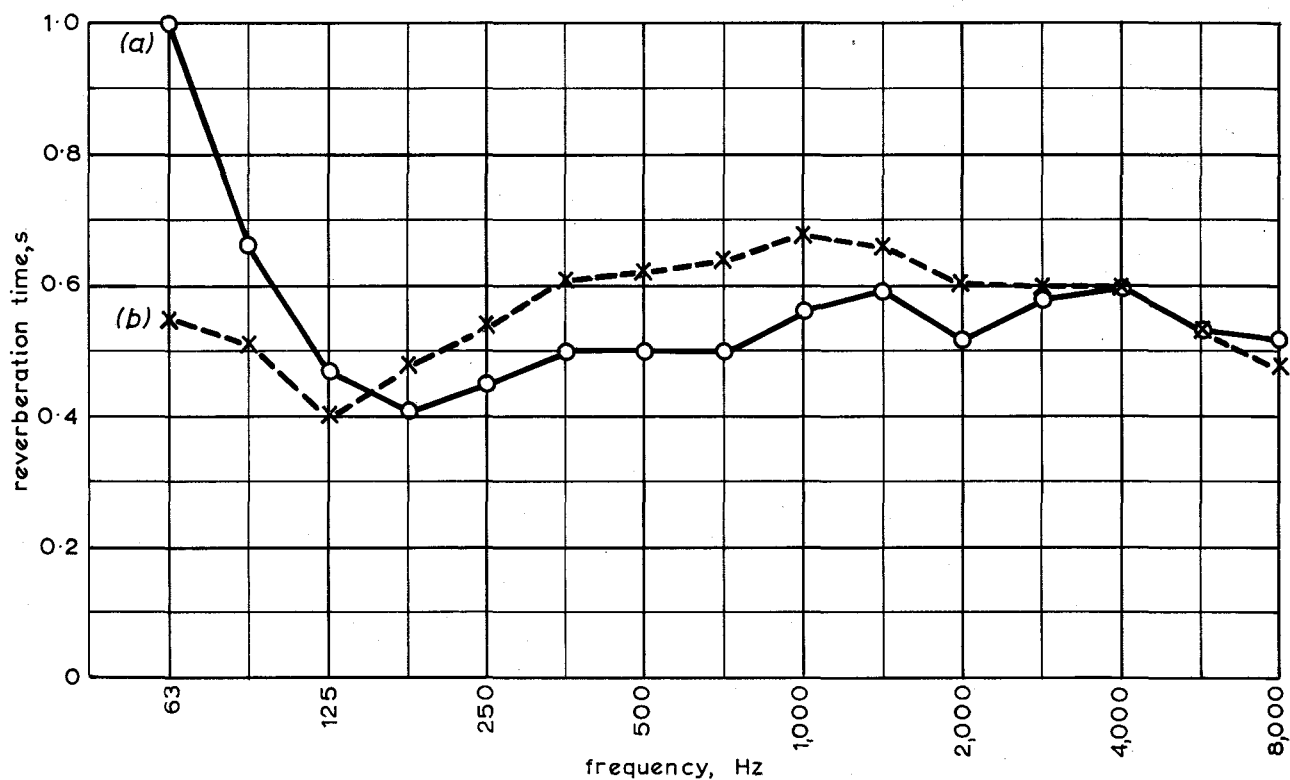
Fig. 1 Reverberation times in Studio 7 Suite

two rooms are plotted in Fig. 1. Curve (a) shows the reverberation time of the studio. The designed reverberation time is approximately 0.32 secs at frequencies above 88 Hz rising to 0.52 secs at 62 Hz. From curve (a) it is seen that the measured reverberation time rises to 1.0 secs at 63 Hz. It is expected that the provision of a carpet, fabric covers to those absorbers which should be so equipped and the usual studio furnishings will reduce the reverberation time at frequencies above 105 Hz to the design figures. The reverberation-time/frequency characteristic of the editing channel, curve (b), is satisfactory.

The excess low-frequency reverberation time in the studio is a serious fault; there are well-defined double slopes in the sound decay curves and the onset of the second slope, which has a decay times of several seconds, is only 15 dB to 20 dB below the excitation level.

The well defined double decays suggested a lightly damped resonant component in the structure of the room as the cause. Examination and accelerometer measurements showed decay times of up to 5 secs at various points on the suspended ceiling structure. The same decay times were obtained, but at higher levels, when the ceiling was shock-excited. It thus seemed likely that the long second decays were due to ceiling resonances and not to undamped room modes.

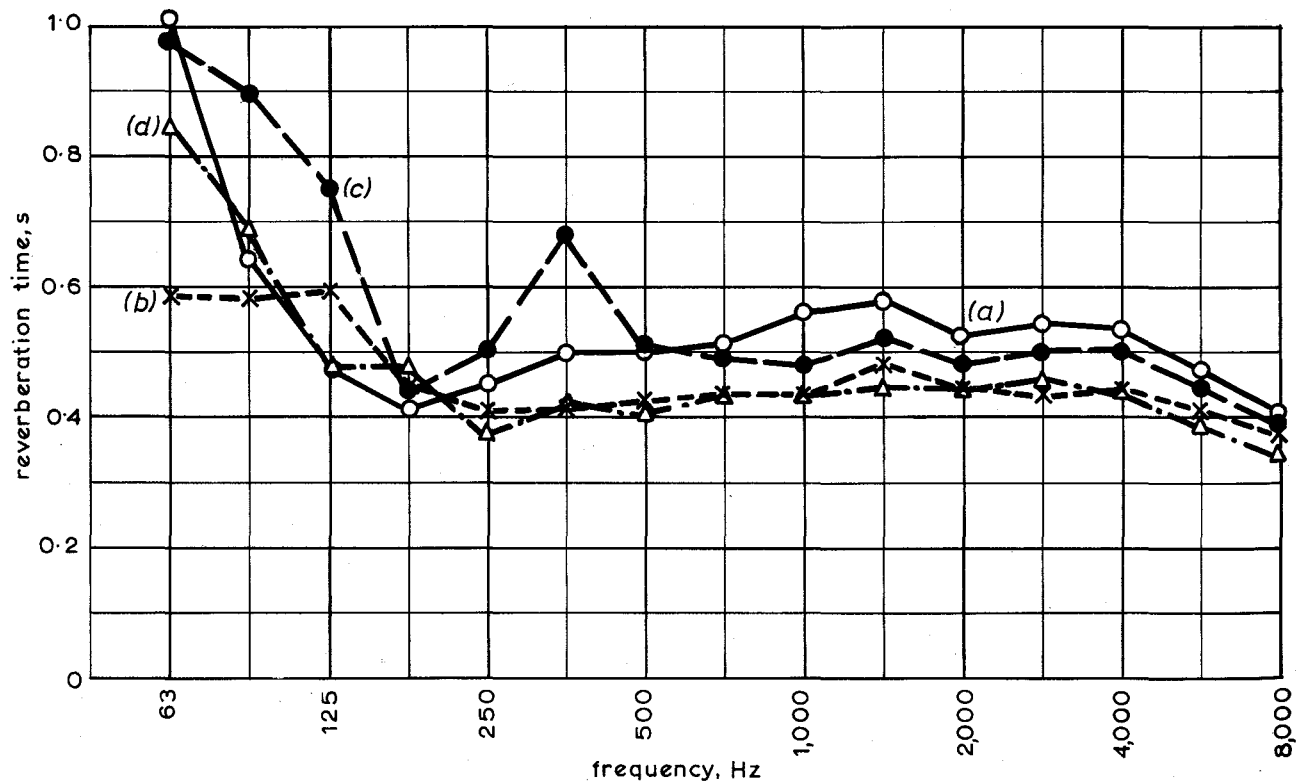
Fig. 2 Reverberation times in Studio 7.

House in which demountable suspended ceilings were used. On a subsequent visit to this studio, 28 of the Echostop tiles were removed and the reverberation times were then measured. These are given in Fig. 2. Corresponding sections of pulsed glides obtained with and without the tiles are given in Fig. 3, from which it can be seen that removal of 28 of the ceiling tiles depressed the onset of the second slope by 10 dB to 15 dB. In this condition, the second slopes were less obvious except when listening with the ear close to the ceiling frame. The second slope could be further depressed by grasping the framework and applying weight.

The problem was discussed with the acoustic architects of Building Department, and it was decided on cost grounds that the ceiling should be stiffened in stages until satisfactory. The simplest possible stiffening was to increase greatly the number of vertical hangers carrying the metal channels into which the tiles were fitted. At the next visit it was found that only two additional hangers had been fitted instead of the recommended twenty, and Fig. 2 shows that the chief effect was to shift the modes of vibration to higher frequencies. It produced a severe peak, centred at 355 Hz, in the reverberation-time frequency-characteristic.

It was then found that the feet of the hangers were all wrongly cut, see Fig. 4, so that the stiffness of the angle iron from which the channelling is suspended was greatly reduced. It was decided therefore, that diagonal bracing should be installed as indicated in Fig. 5. It will be seen from Fig. 2 that the effect of this bracing was to reduce the reverberation time to 0.45 secs at frequencies above 180 Hz. A noticeable effect of this modification was that the onset of the second slopes had been depressed to a point about 30 dB below the excitation level. The long second decays at low frequencies were still just audible when excited acoustically by warbled tone, but it was thought that the studio would be satisfactory for speech.

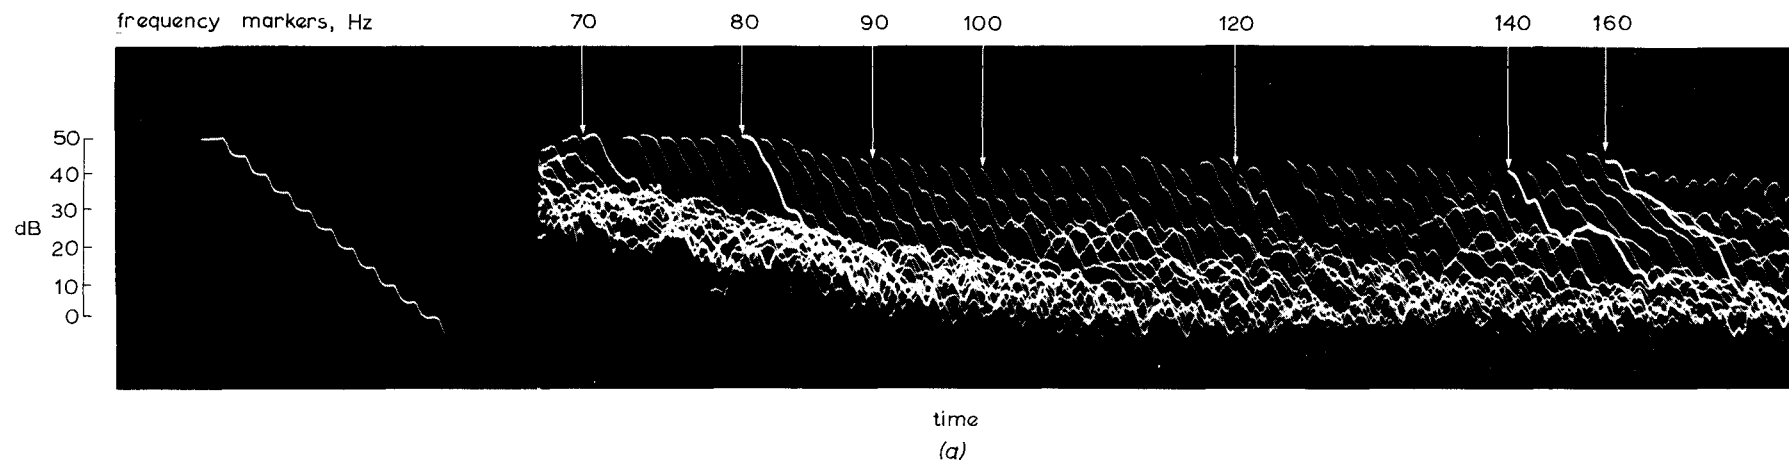
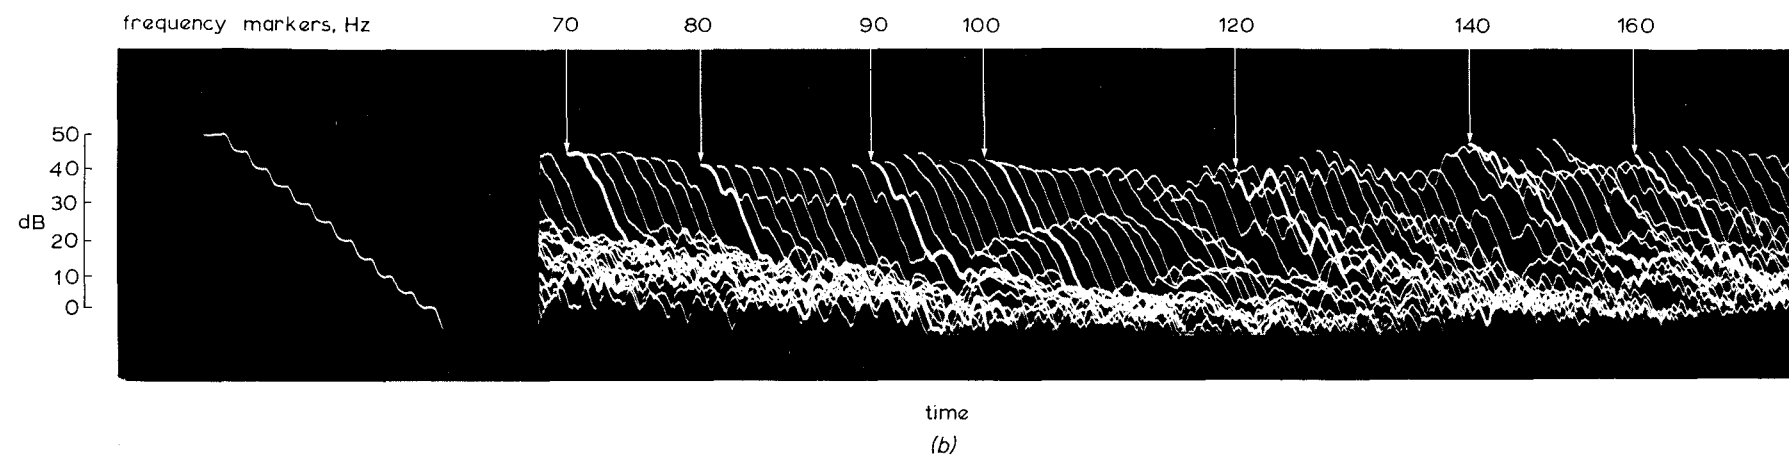
Fig. 3 Pulsed glides obtained in Studio 7.

A vibration generator was used to drive the framework and the excitation frequency was varied from 40 Hz up to 1 kHz. The output of an accelerometer which was attached to the framework showed that there was a series of modes of vibration having Q-factors in excess of 25.

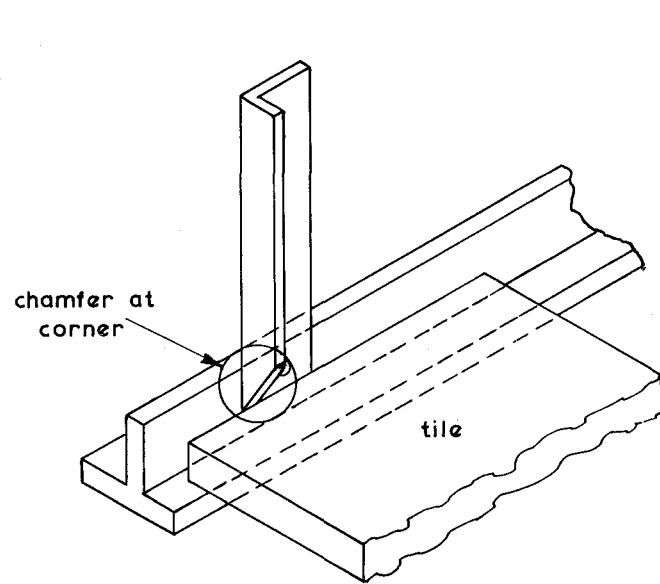
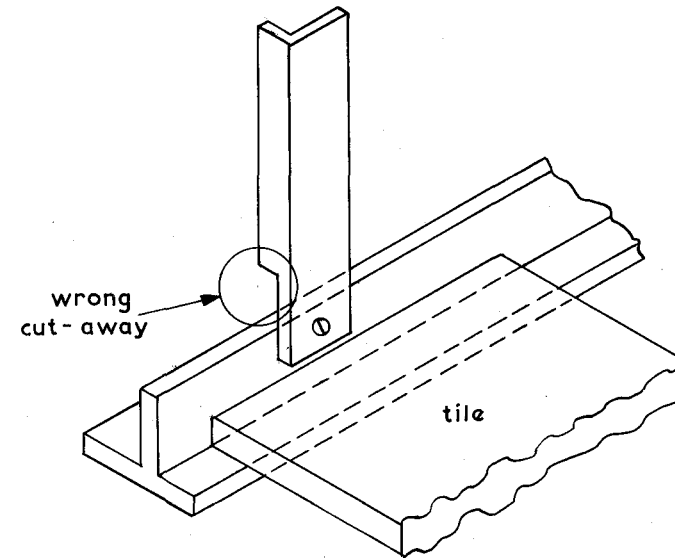
Fig. 4 Details of ceiling hangers
in Studio 7.

(b) As installed.

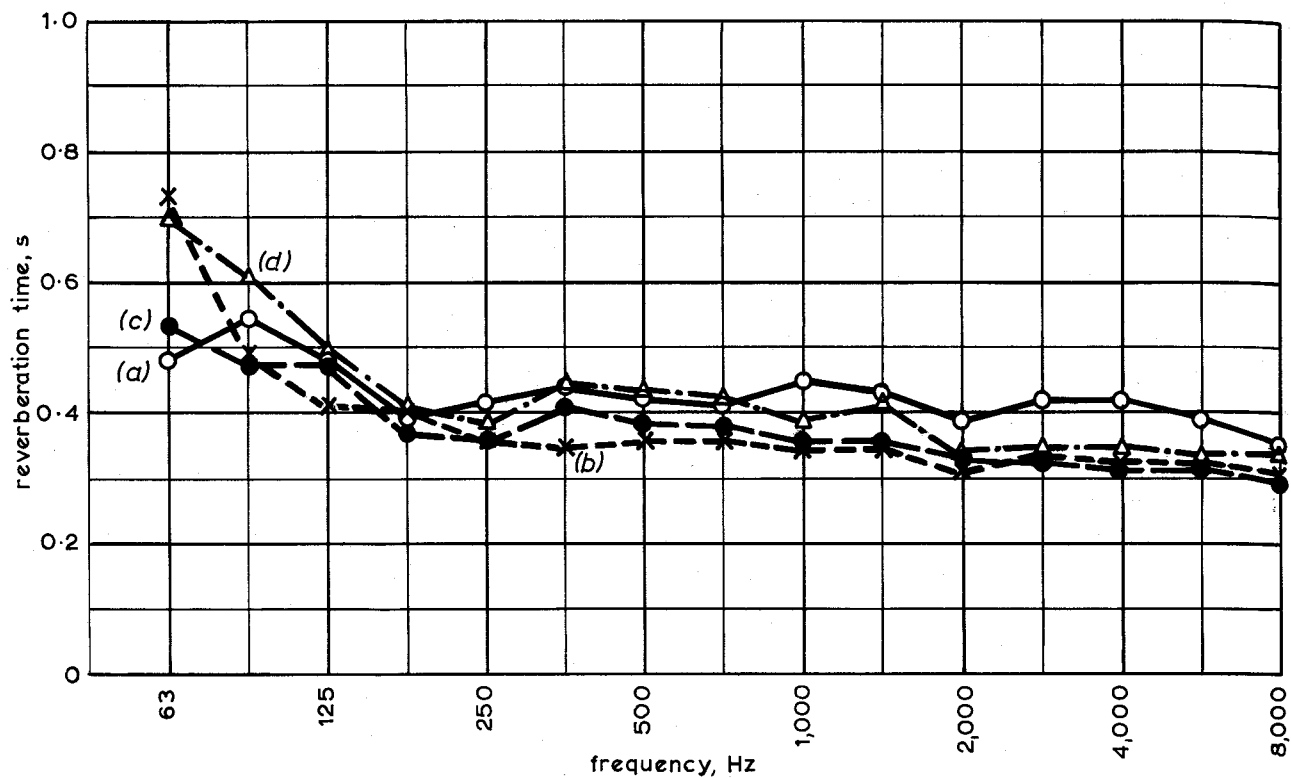
Fig. 6 Reverberation times in Studio 7.

On a later visit further reverberation times were measured from the slope of the first 30 dB of the decays with the tiles in place and then with 28 of the tiles removed. A temporary carpet was laid to obtain a realistic reverberation time at higher frequencies. Fig. 6 shows the results, from which it can be seen that, with the additional stiffening installed, the removal of 28 of the ceiling tiles does not now greatly affect the reverberation times. Critical listening tests were carried out on speech, and it was agreed that, except with one speaker who

was suffering from a cold, colourations due to the second slopes of the decay curves were not noticeable.

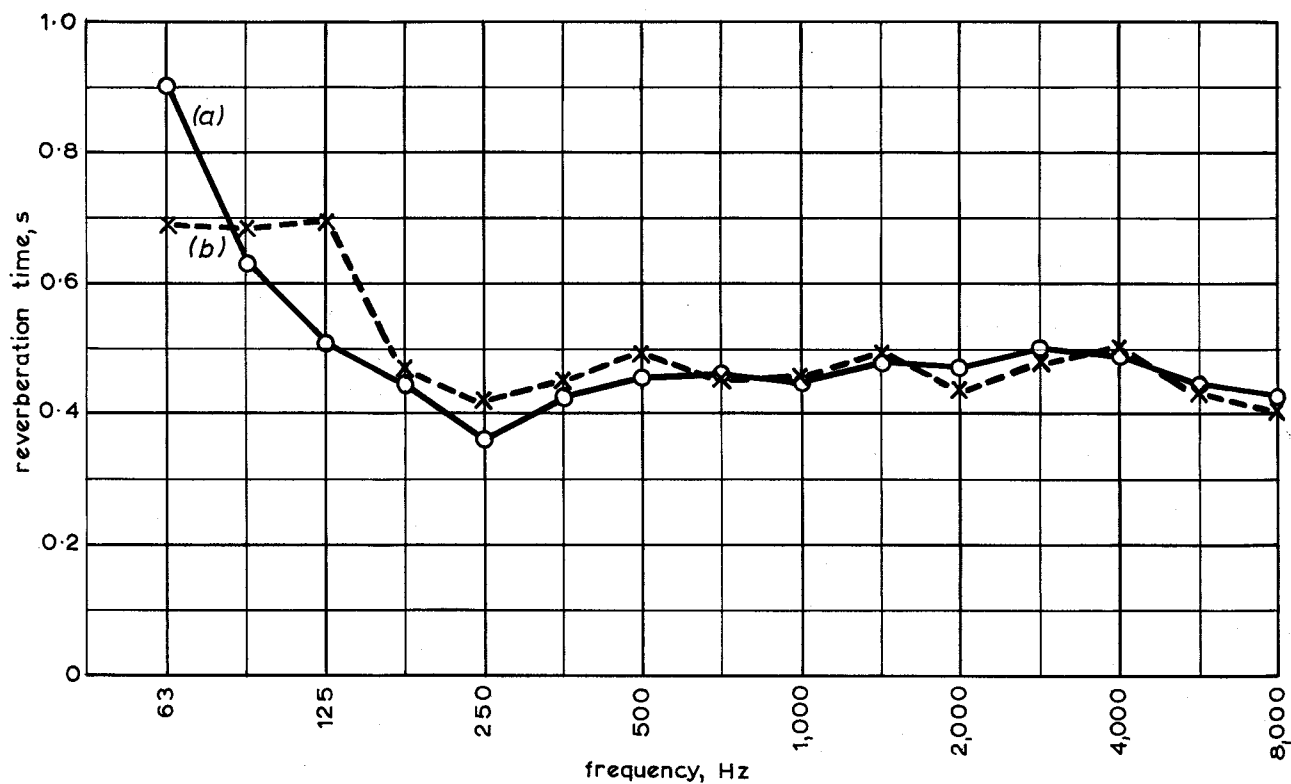
Fig. 7 Reverberation times in Studio 8 Suite

The reverberation-time frequency-characteristics for these two rooms are shown in Fig. 7. The rooms were incomplete and no carpets were fitted. It is probable that fitted carpets, furniture and furnishings will reduce the high frequency reverberation times to the design figure of 0.32 secs at frequencies above 500 Hz. The excessive reverberation times at frequencies below 180 Hz are caused by the suspended ceilings. The long second slopes start some 25 dB below the excitation level and will probably be noticeable on music; speech quality may be satisfactory.

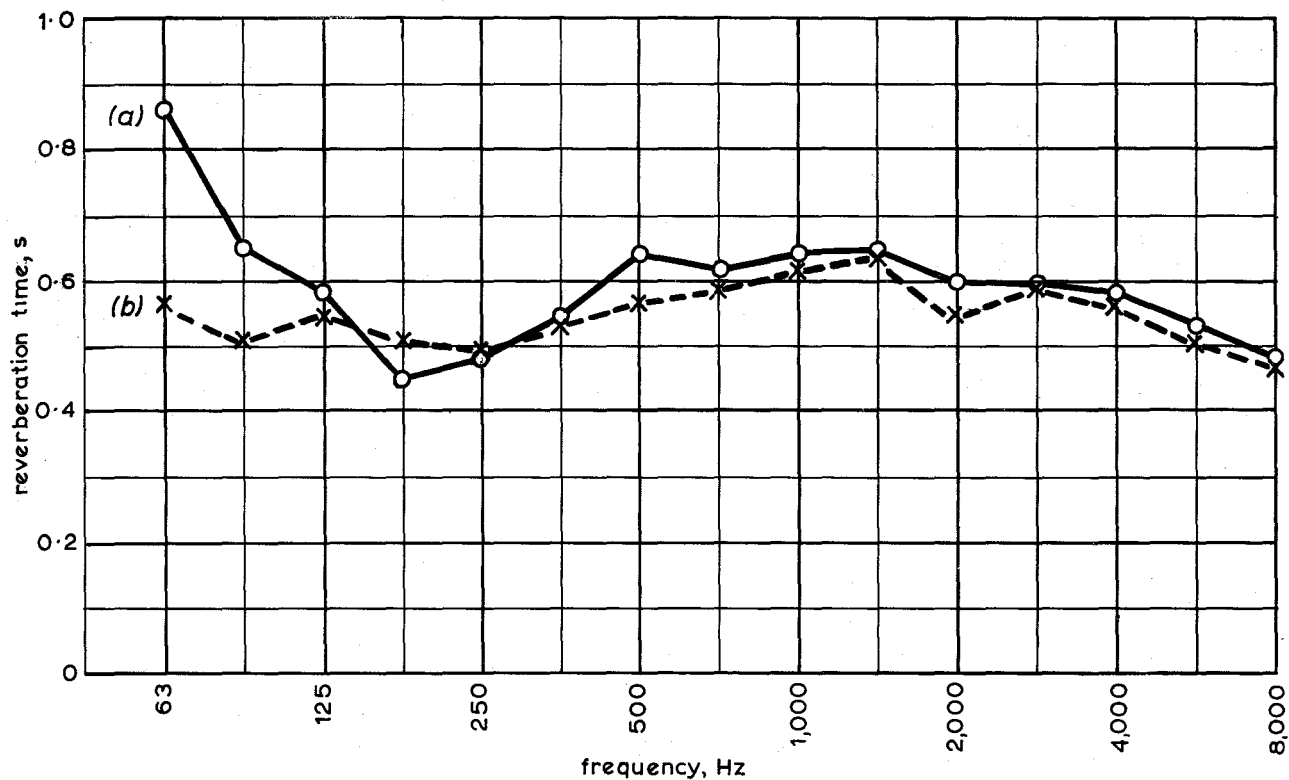
Fig. 8 Reverberation times in Channels W8 and W9.

The reverberation times for these two rooms are given in Fig. 8, from which we see that the low frequency reverberation times are again excessive due to second slopes in the decay curves. Provision of carpets, furniture and furnishings should reduce the reverberation times at the higher frequencies to the designed figure.

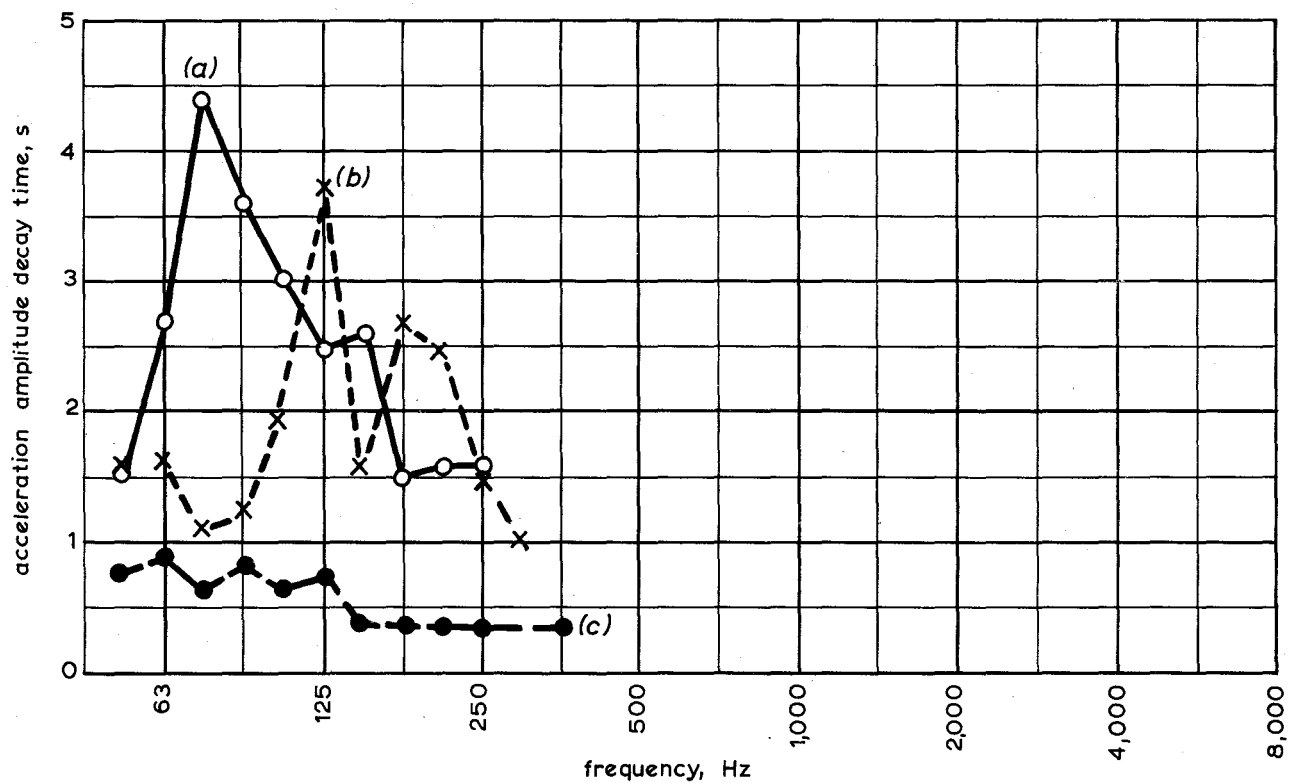
Fig. 9 Decay times of framework in Studio 1.

At the request of Building Department, measurements were carried out on a small section of the framework which had been completed for the purpose and loaded with typical absorbing units. The framework was driven by a vibration generator, an accelerometer was attached to points on the framework and the output of the accelerometer was applied to the normal reverberation time measuring equipment. The drive and pick-up were both in the direction normal to the wall and the decay times obtained are plotted in Fig. 9 which shows that some decay times were of the order of 4 secs. In order to measure the decay times it was necessary to stop a diesel engine working on the site because the airborne sound from the engine excited the framework into vibrations of sufficient amplitude to interfere with the reading of the decays. This suggests strongly that the airborne sound produced by an orchestra performing in the studio would be capable of exciting the framework and that the 4 secs decay times of the structure would then produce colourations of the sound. It was decided to stiffen the structure in a series of stages. The first stage, which was not expected to be particularly effective was to install simple diagonal bracing. This increased the vertical stiffness appreciably but provided little increase in stiffness of the structure in the direction normal to the wall. Fig. 9 curve (b) shows the long decay times obtained. Wooden "V" braces were then applied to the framework, the apex of the "V" being fixed to the outer plane of the framework and the feet of the "V", 1.21 m apart, being attached to the vertical angle iron at the surface of the wall. It was further specified that at the points of attachment of the feet of the "V" bracing to the angle iron, the angle iron itself should be bolted back to the wall. Thus the framework would be fixed to the wall at 1.2 m centres instead of at 3.6 m centres. Measurements of decay times of the framework were again made and the results are shown as curve (c), Fig. 9, from which it is evident that the "V" bracing plus the extra fixing bolts successfully reduced the decay times of the loaded framework to values much lower than 1.6 secs, the designed reverberation time for the studio. Providing that the wooden "V" braces and extra fixing bolts are installed, as specified to Building Department, it is not anticipated that this method of mounting the acoustic treatment will produce undesirable effects.

The angle iron framework designed to support the acoustic treatment has been shown to be a source of excessive reverberation times. A section of the framework has been stiffened by the addition of "V" braces and by trebling the number of pins fixing the framework to the walls. Measurements have shown that the additional bracing and fixing pins as specified should prevent low frequency colourations in the completed studio. It will be necessary to ensure that the gaps between the concrete-clad steel joists and the brick panels are well packed and that the compliant wall ties are not bridged by mortar.

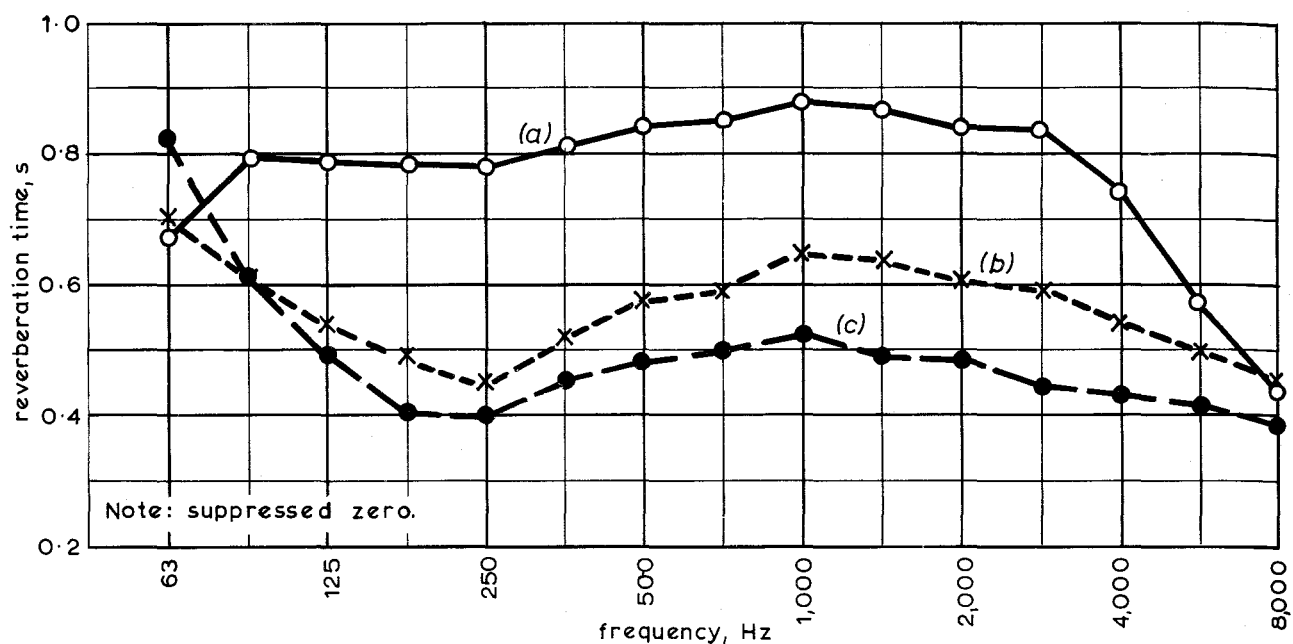
Fig. 10 Reverberation times in Studio 2 Suite

Measurements of reverberation times and of background noise levels were made in Studio 2, its recording room and its control cubicle. Fig. 10, curves (a), (b) and (c) respectively show the reverberation times in the three areas. No carpets were fitted and the fabric covers to the absorbers were not in place. Pronounced rattles and rings of the lighting fittings in the studio obscured the last 20 dB of the decay curves at frequencies of 63 Hz and 88 Hz and the quoted reverberation time at these frequencies was obtained from the first 30 dB of the decays.

The reverberation times measured in the recording room and the control cubicle both exhibit the low frequency rise typical of small studios at Baynton House. The second slopes in the decay curves due to the suspended ceilings start 25 dB to 30 dB below the excitation level. Installation of studio furniture, equipment, carpet and fabric covers should reduce the high frequency reverberation times adequately.

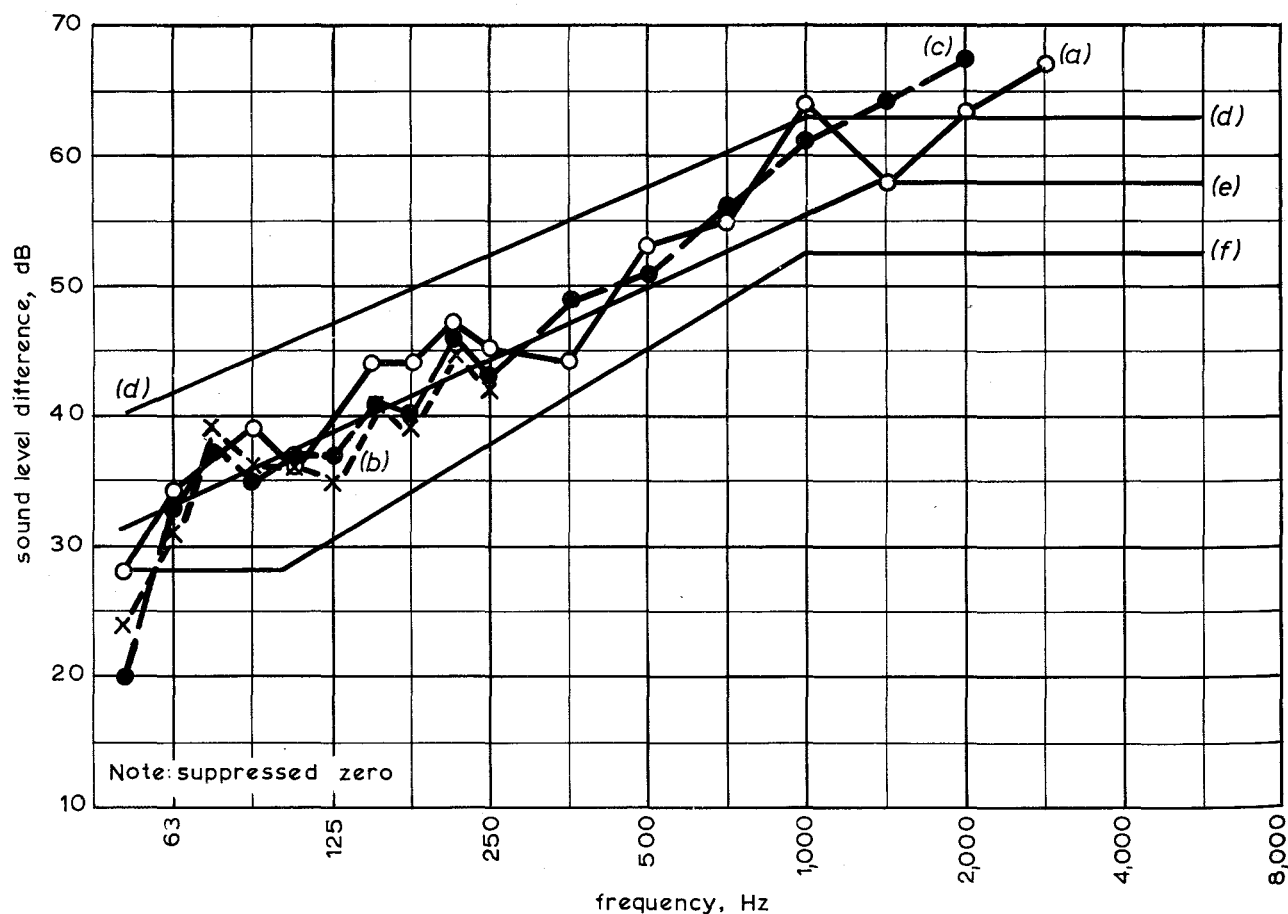
Fig. 11 Sound insulation measurements in Studio 2 Suite

Measurements of sound insulation were made from the studio to the recording room, from the studio to the control cubicle and from the studio to the narrator's studio. The measurements of sound insulation in the recording room were limited to frequencies below 250 Hz by the excessive ventilation noise. The curves are given in Fig. 11, together with the criterion curves. The insulations are adequate from the studio to the narrator's studio and from the studio to the control cubicle. The insulation from the recording room to the studio is likely to be insufficient since the programme will normally be monitored from the replay heads of recording machines and will therefore be delayed. For such cases it has been found that the insulation should be equivalent to that required between a studio and a cubicle or editing room monitoring a different programme. Large holes in the walls above suspended ceiling level between the recording room and the control cubicle prevented meaningful measurements of insulation between these areas. The existence of these holes and similar holes in other areas was notified to Building Department for their attention.

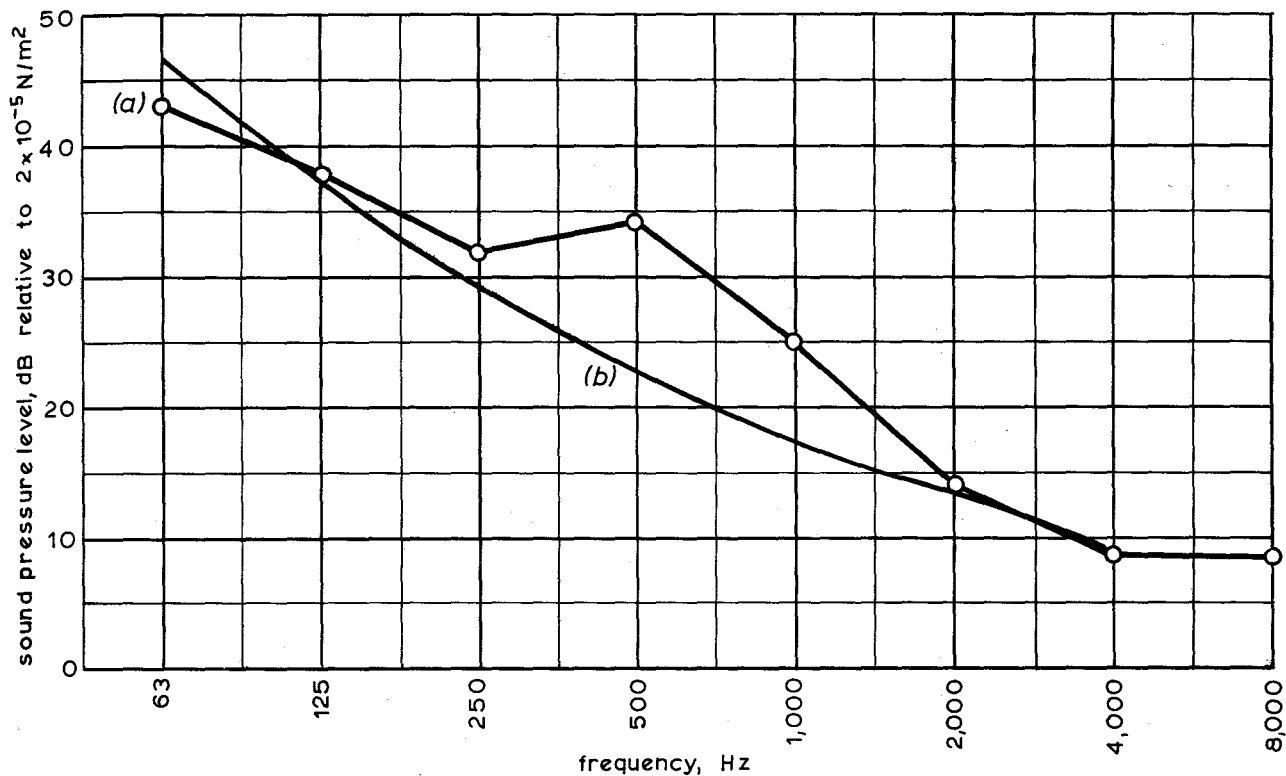
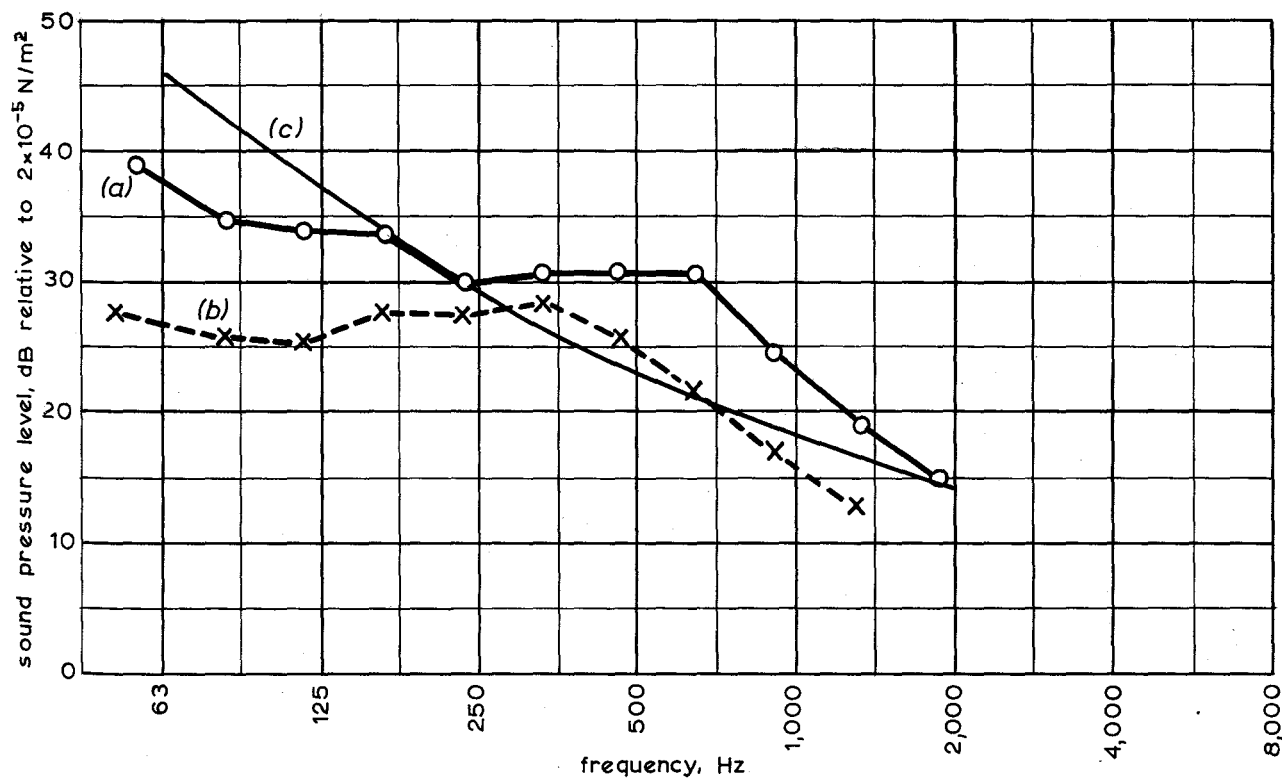
Provisional background noise levels are given in Fig. 12 for the studio and in Fig. 13 for the control cubicle and the recording room. No inlet and extract grilles were fitted in the studio. The measurements in the control cubicle and the recording room were obtained with a peak reading instrument and the curves have been lowered by 5 dB to give an equivalent r.m.s. value. As can be seen from Fig. 12 even in the absence of grilles the noise level is excessive in the 500 Hz region. The measurements must be considered provisional because the ventilation system is not yet balanced and some of the inlet and extract grilles are missing.

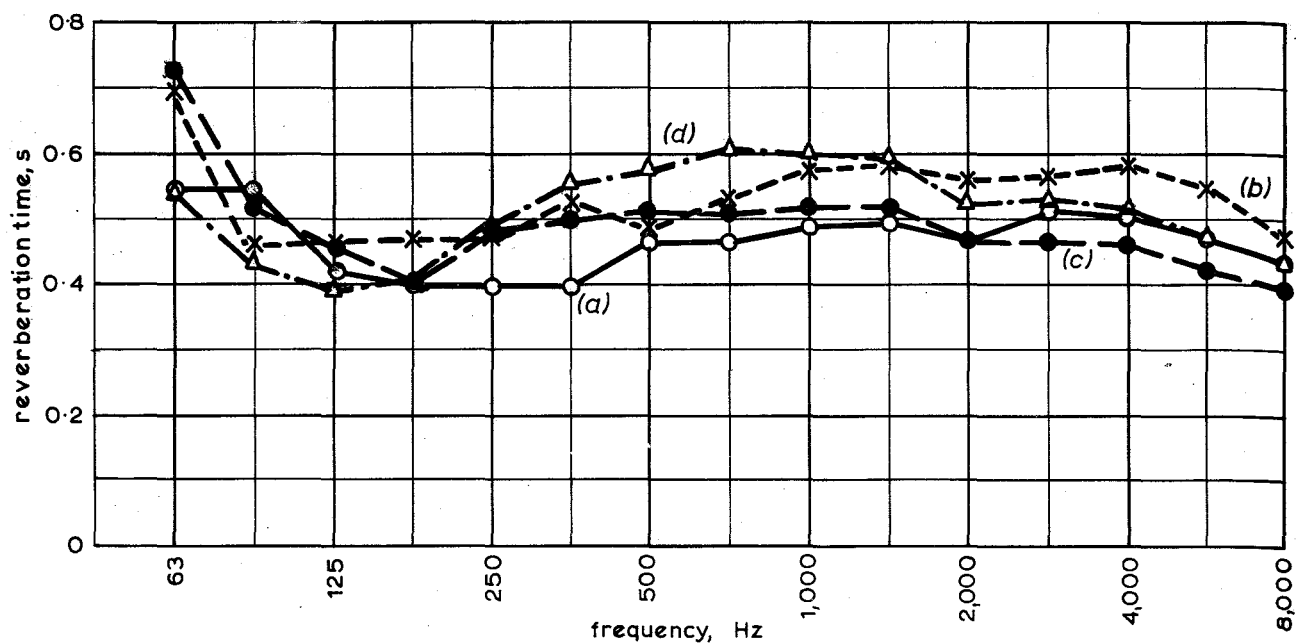
Fig. 14 Reverberation times in Studio 3 areas.

The reverberation curves for the Narrator's Studio (a), Studio 3 (b), its control cubicle (c) and its recording room (d) are shown in Fig. 14. The decay curves again exhibit second slopes starting about 25 dB below the excitation level. The

reverberation curves shown ignore the effects of the second slopes of the readings and are confined to the first 25 dB to 30 dB of the decays. No carpets or fabric covers were fitted and provision of these together with the usual furniture should reduce the high frequency reverberation times to acceptable values.

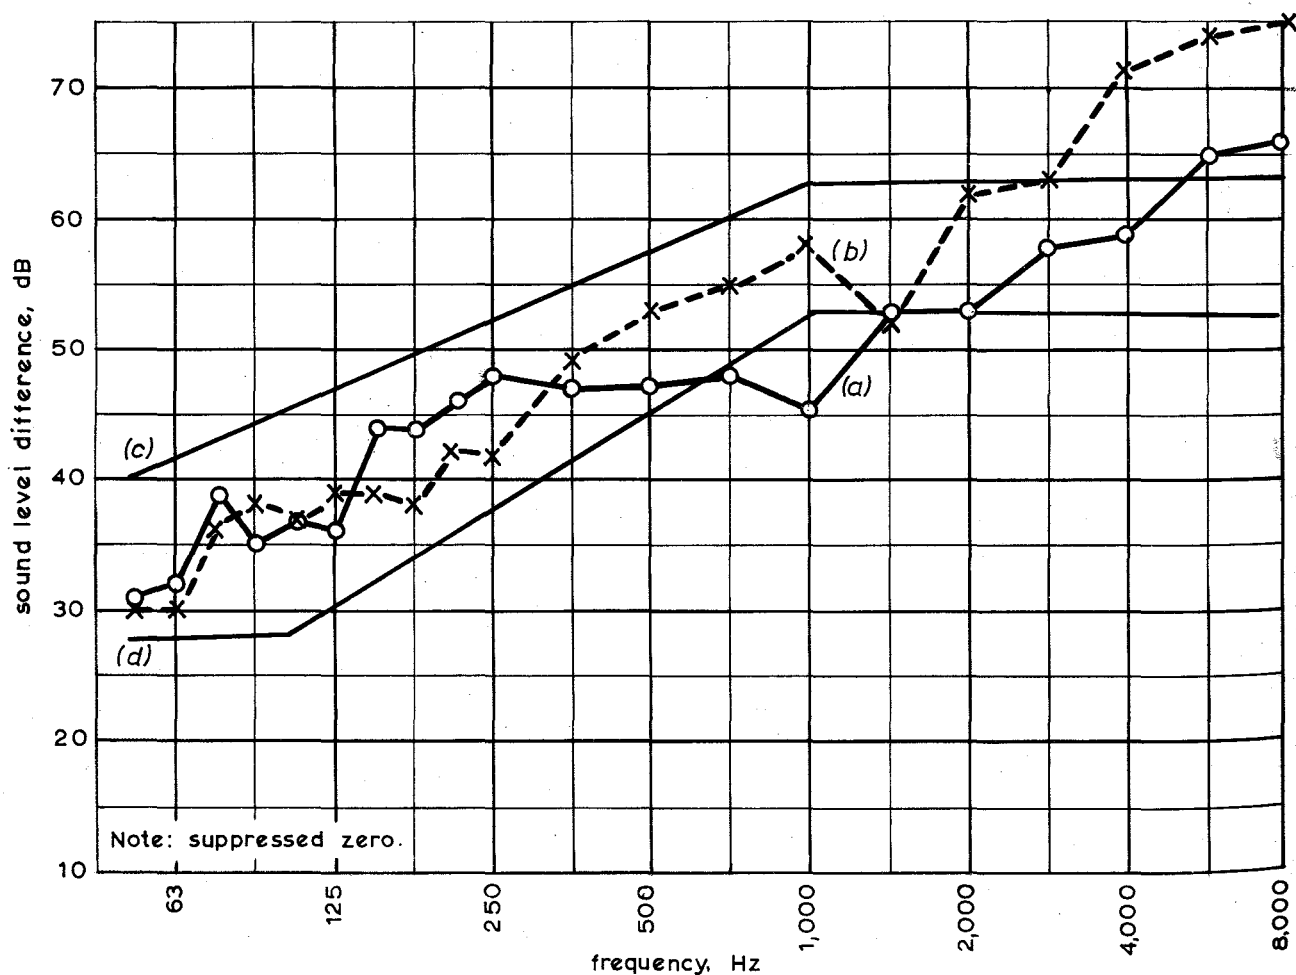
Fig. 15 Sound level differences.

It was useless to attempt to measure sound insulation between the narrator's studio and Studio 3 or between the control cubicle and recording room as there were large unblocked holes in the walls above the level of the suspended ceilings. Fig. 15 curves (a) and (b) show the sound insulation measured from Studio 3 to its control cubicle, and from Studio 3 to its recording room respectively, together with the appropriate criterion curves. The insulation from the studio to its control cubicle is satisfactory, but that from studio to recording room is, for the reasons given in 3.2. for another suite, probably insufficient.

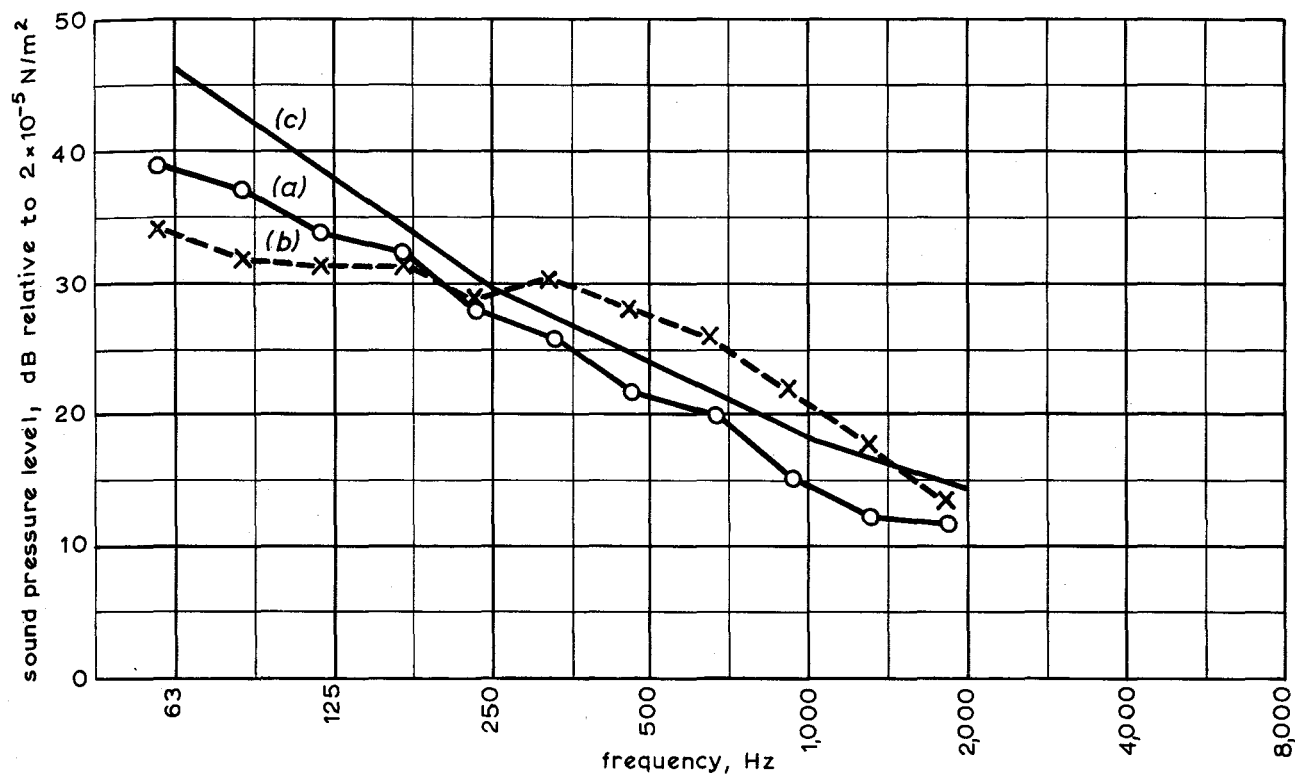
Fig. 16 Provisional noise levels in Studio 3.

Provisional noise levels from Studio 3 and the narrator's studio are given in Fig. 16. No inlet or extract grilles were fitted and the noise levels in Studio 3 are excessive. In the absence of grilles, the noise level in the narrator's studio is just satisfactory. Provisional noise levels in the control cubicle and recording rooms are given in Fig. 17. The grilles are fitted in these areas and, as is typical of the type of grilles fitted in the studio block, excessive noise is produced by mechanical vibration of the grille vanes, showing peaks in the 350 Hz region. The figures quoted have been converted to r.m.s. by subtraction of 5 dB. It is understood that the ventilating contractors are making modifications.

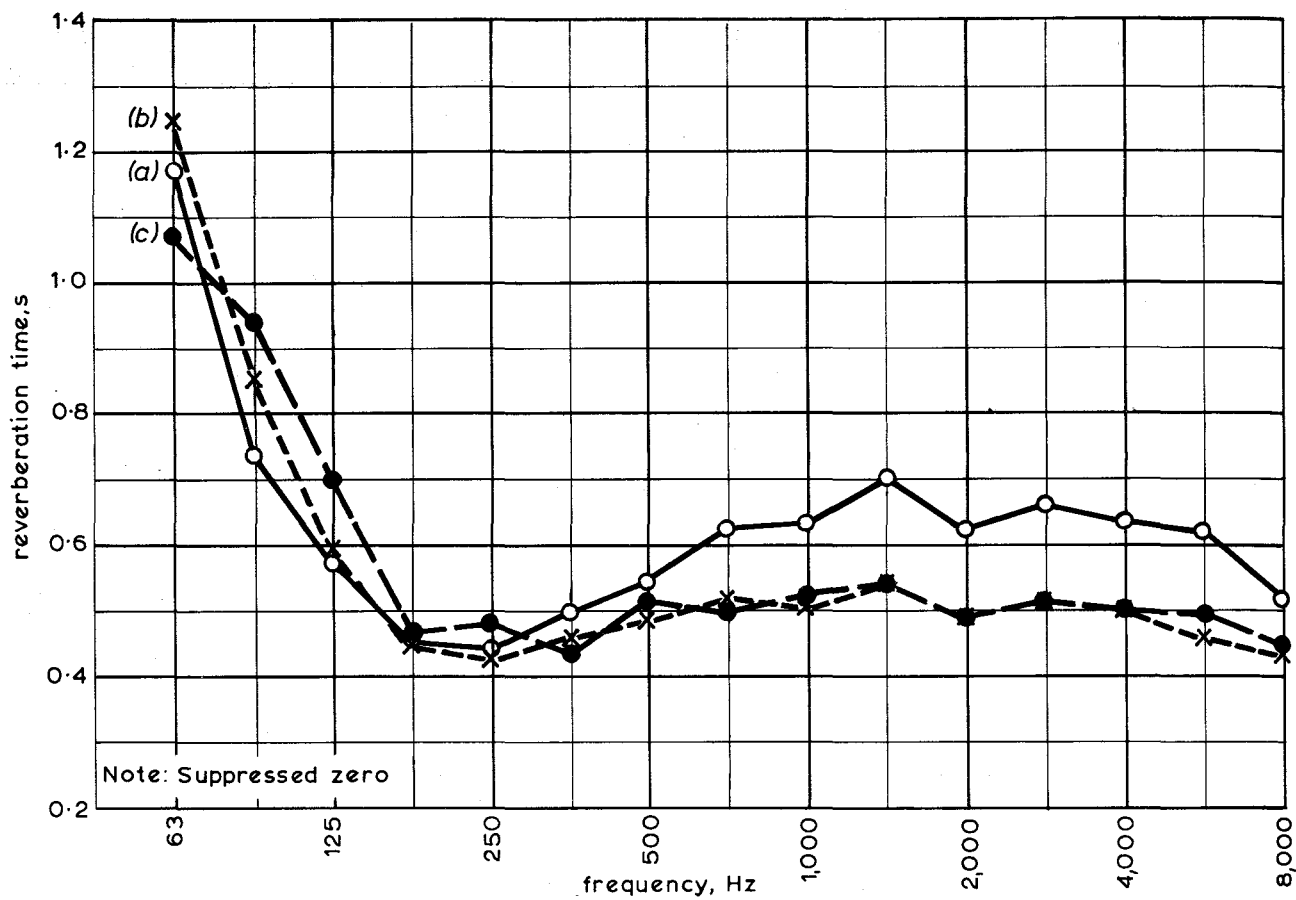
Fig.18 Reverberation times in Studios 4,5 and 6.

Reverberation times, sound insulations and background noise levels were measured in these areas. From Figs. 18 and 19, it will be seen that these rooms all have high reverberation times at low frequencies. The second decays start 20 to 30 dB below the excitation level and may well make their presence evident on speech. Carpets, fabric covers to the absorbers and studio furniture should reduce the high frequency reverberation time to the design figure.
